# Manhole Inspection Summary

Manhole # S25I\_\_049MH

**Location** Address: **S Stockton St**

Cross Street: **Lemmon St**

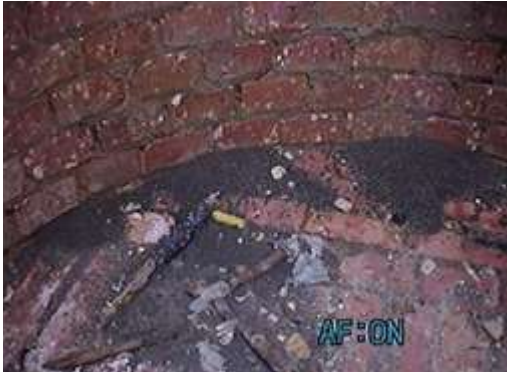
Misc.

Condition: ☐ Sound ☐ Cracked ☐ Root Intrusion ☐ Deteriorated ☐ Leaks ☒ **Debris**

debris on bench

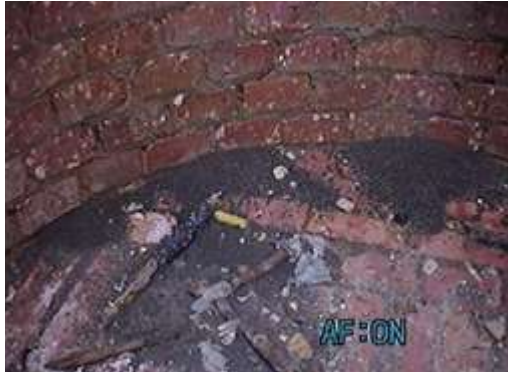
Defect 6

debris on bench

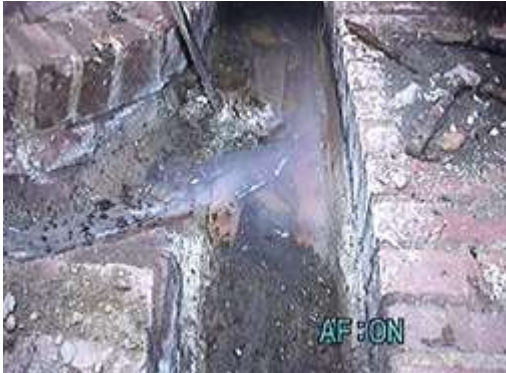
Defect 4

debris in channel

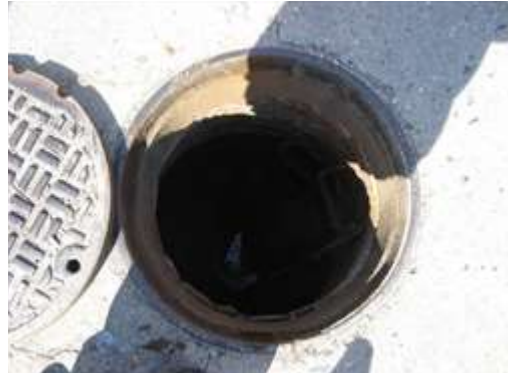
Defect 6

Offset: **0.5** (in.)

frame offset

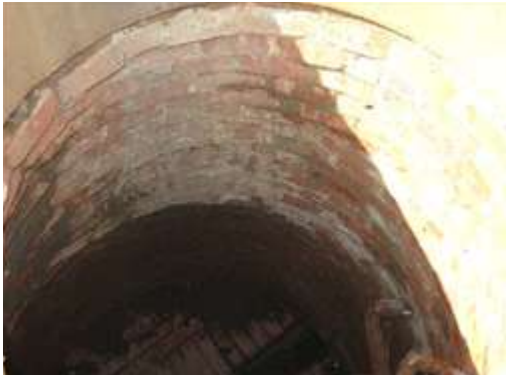
Defect 3

Infiltration: ☐ None ☐ Joint ☐ Cracks ☐ Mortar ☐ Roots ☒ **Wall**

barrel infiltration

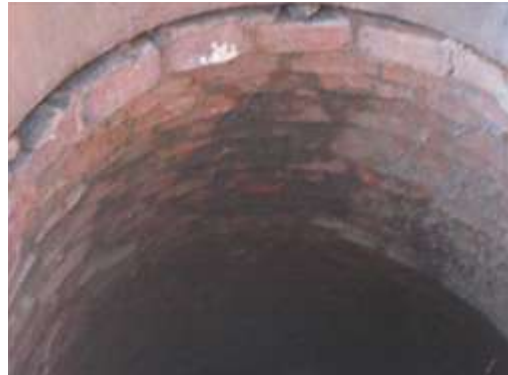
Defect 2

Condition: ☐ Sound ☐ Cracked ☐ Root Intrusion ☒ **Loose Brick** ☒ **Deteriorated**

Infiltration: ☐ None ☐ Joint ☐ Cracks ☐ Mortar ☐ Roots ☒ **Wall**

deteriorating, loose bricks in chimney with infiltration

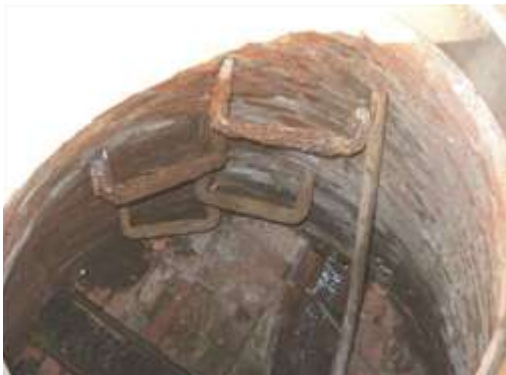
Defect 1

Count: **4** Missing: **0** ☒ **Corroded**

corroded steps

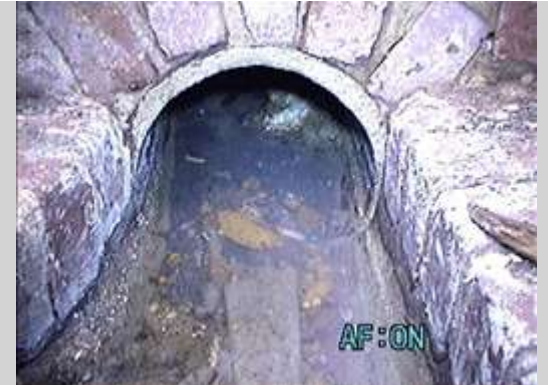
12 O'Clock Outflow

Pipe Height: **8.4** (in.) Rod and Bar (Angled)  
Pipe Material: **Clay** ☐ Pipe Lined  
Invert Depth: **8.63** (ft.) Flow Characteristics: **Slow**  
Deposits: ☐ None ☐ Mud ☐ Sludge ☒ **Debris** ☐ Grease  
Silt Depth: **2** (in.) Deposits Extent: **Light**  
Infiltration: **None** Pipe Seal Cond: **Sound**

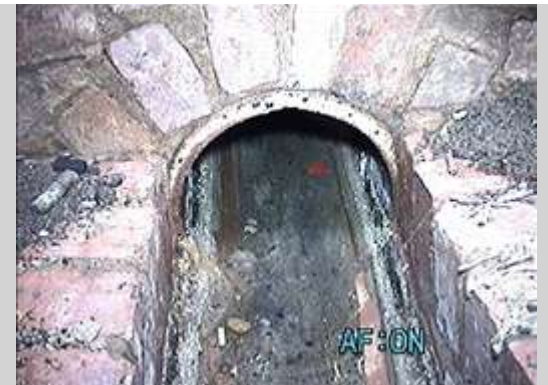
6 O'Clock Inflow

Pipe Height: **8.4** (in.) Rod and Bar (Angled)  
Pipe Material: **Clay** ☐ Pipe Lined  
Invert Depth: **8.65** (ft.) Flow Characteristics: **Slow**  
Deposits: ☐ None ☐ Mud ☐ Sludge ☒ **Debris** ☐ Grease  
Silt Depth: **2** (in.) Deposits Extent: **Light**  
Infiltration: **None** Pipe Seal Cond: **Sound**
